Case Studies III: Rehabilitation of the Yarqon River, a Mediterranean Climate Polluted Stream Ecosystem, and the Reintroduction of the Yarqon Bleak - an Israeli Endemic Critically Endangered Freshwater Cyprinid Fish

Yonathan Raz
Yarqon River Authority

**Rehabilitation of the Yarqon river, a
Mediterranean Climate polluted stream
Ecosystem, and the reintroduction of the
Yarqon bleak- an Israeli endemic critically
endangered freshwater cyprinid fish**

**Yonathan raz
ISRAEL**

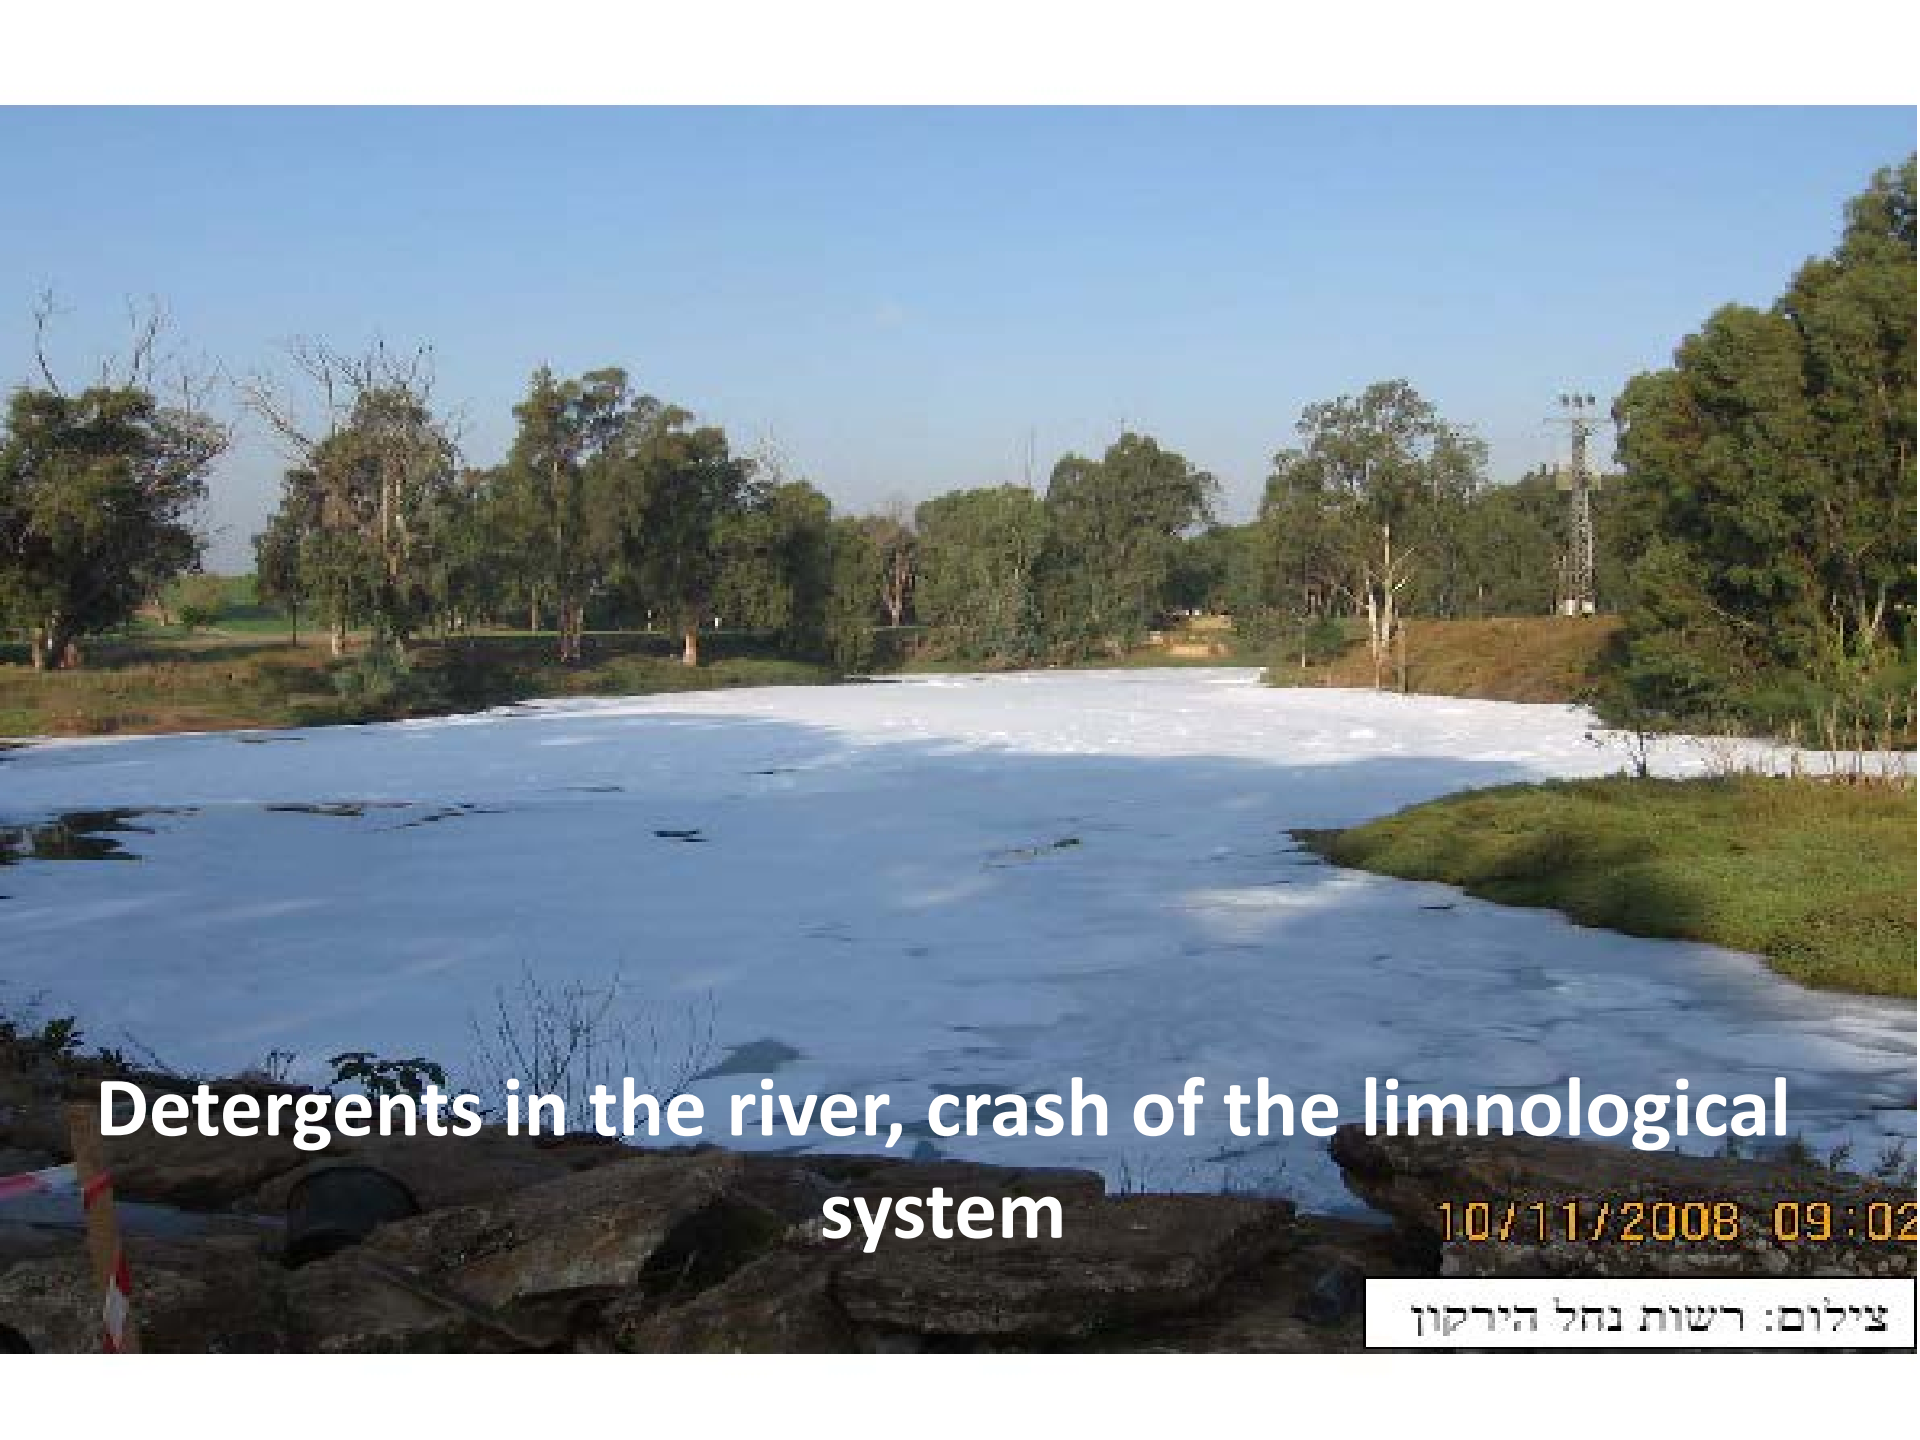
Wastewater treatment facility flooded with detergents

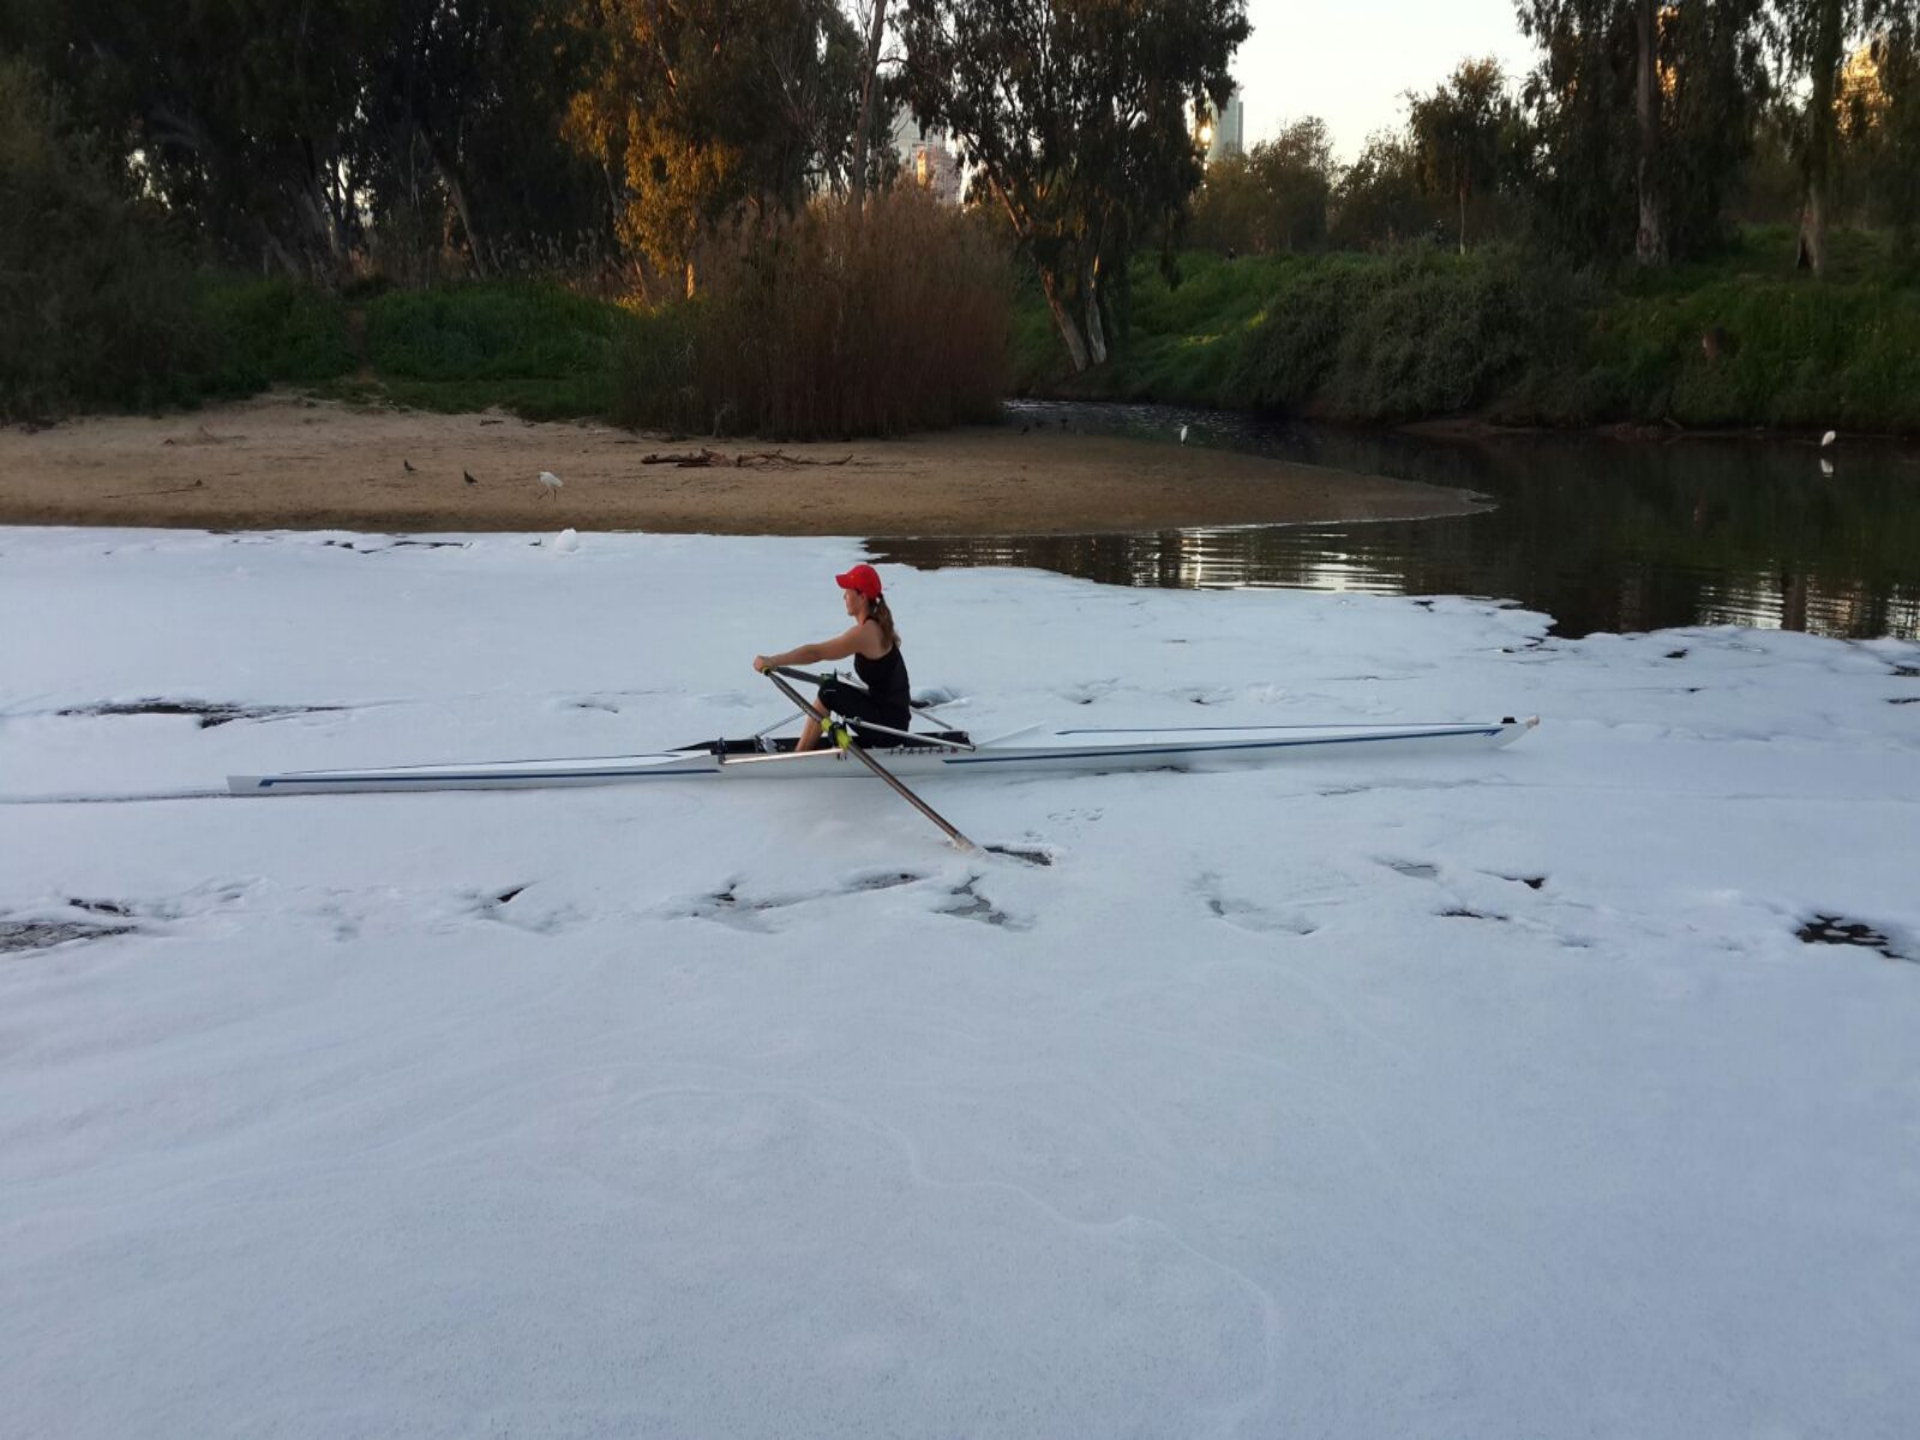
Detergents in the river, crash of the limnological system

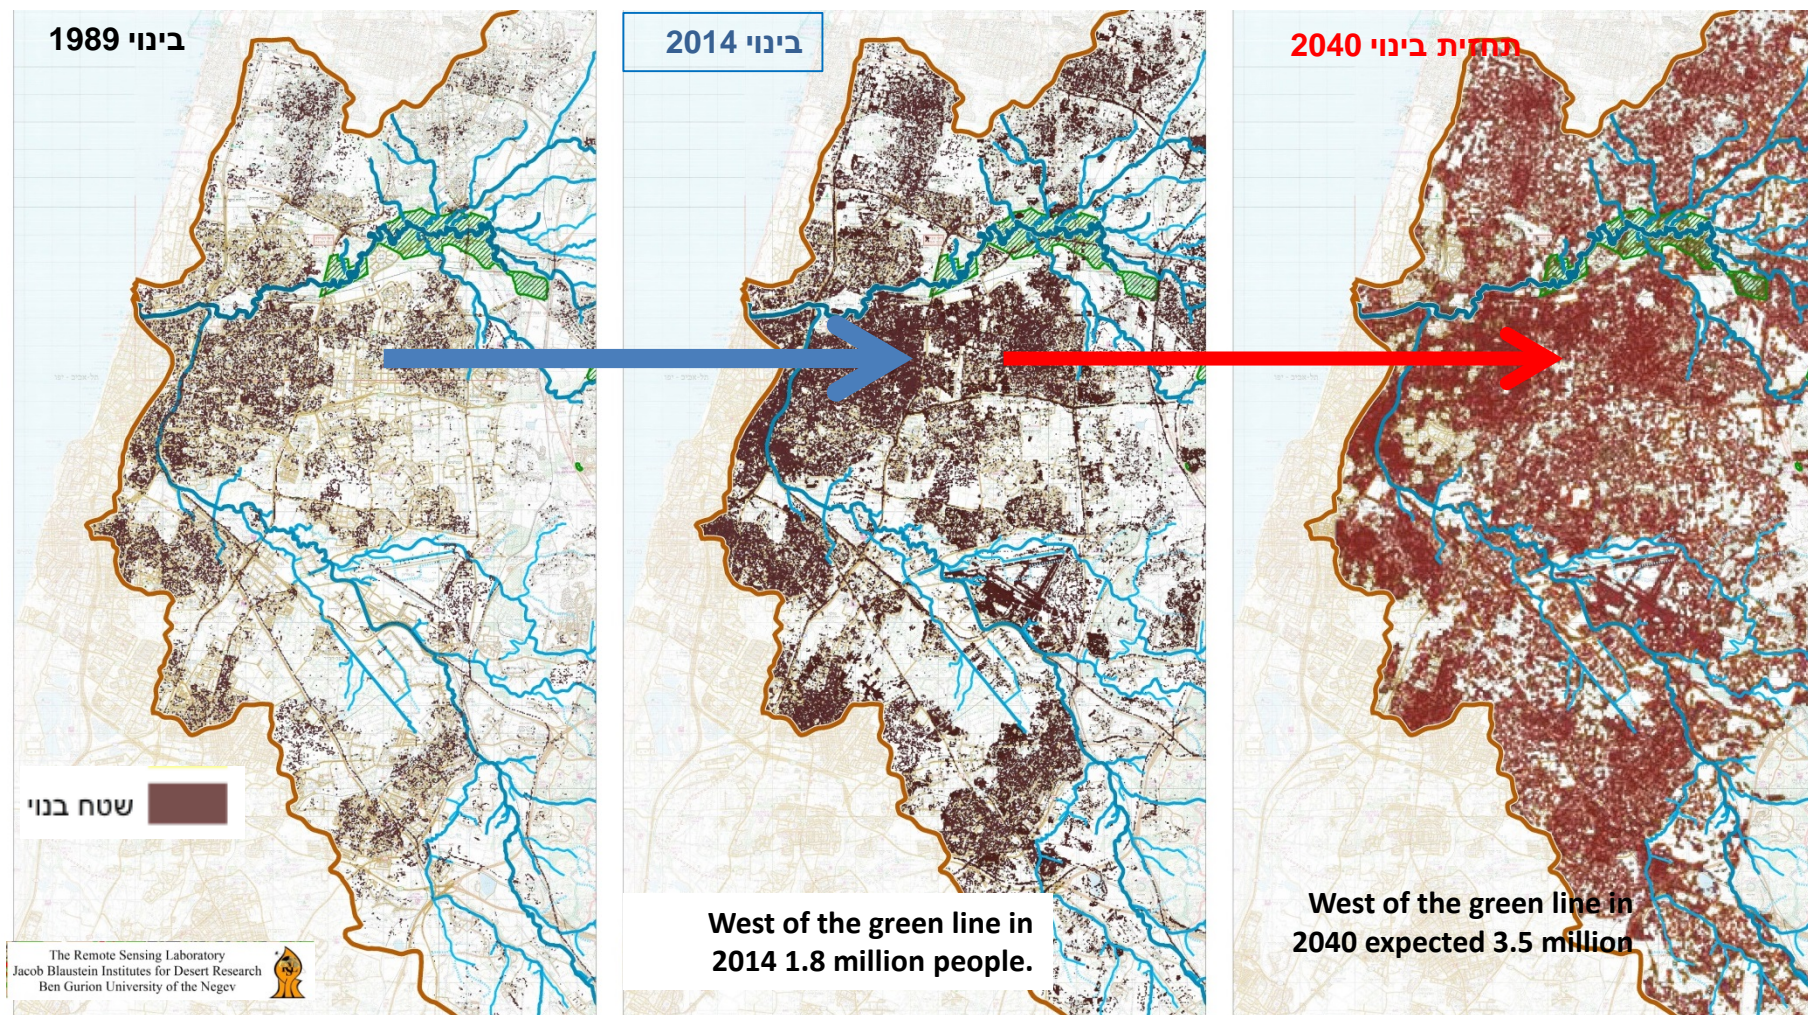
The Yarkon basin – comparing urbanization 1989-2014-2040 and predictable population growth

4%	3%	2%	Percent population growth in the basin (in millions)	
2.5	2.5	2.5	2014	* According to the Administration's data growth today is approximately 2.2%
6.7	5.2	4.1	2040

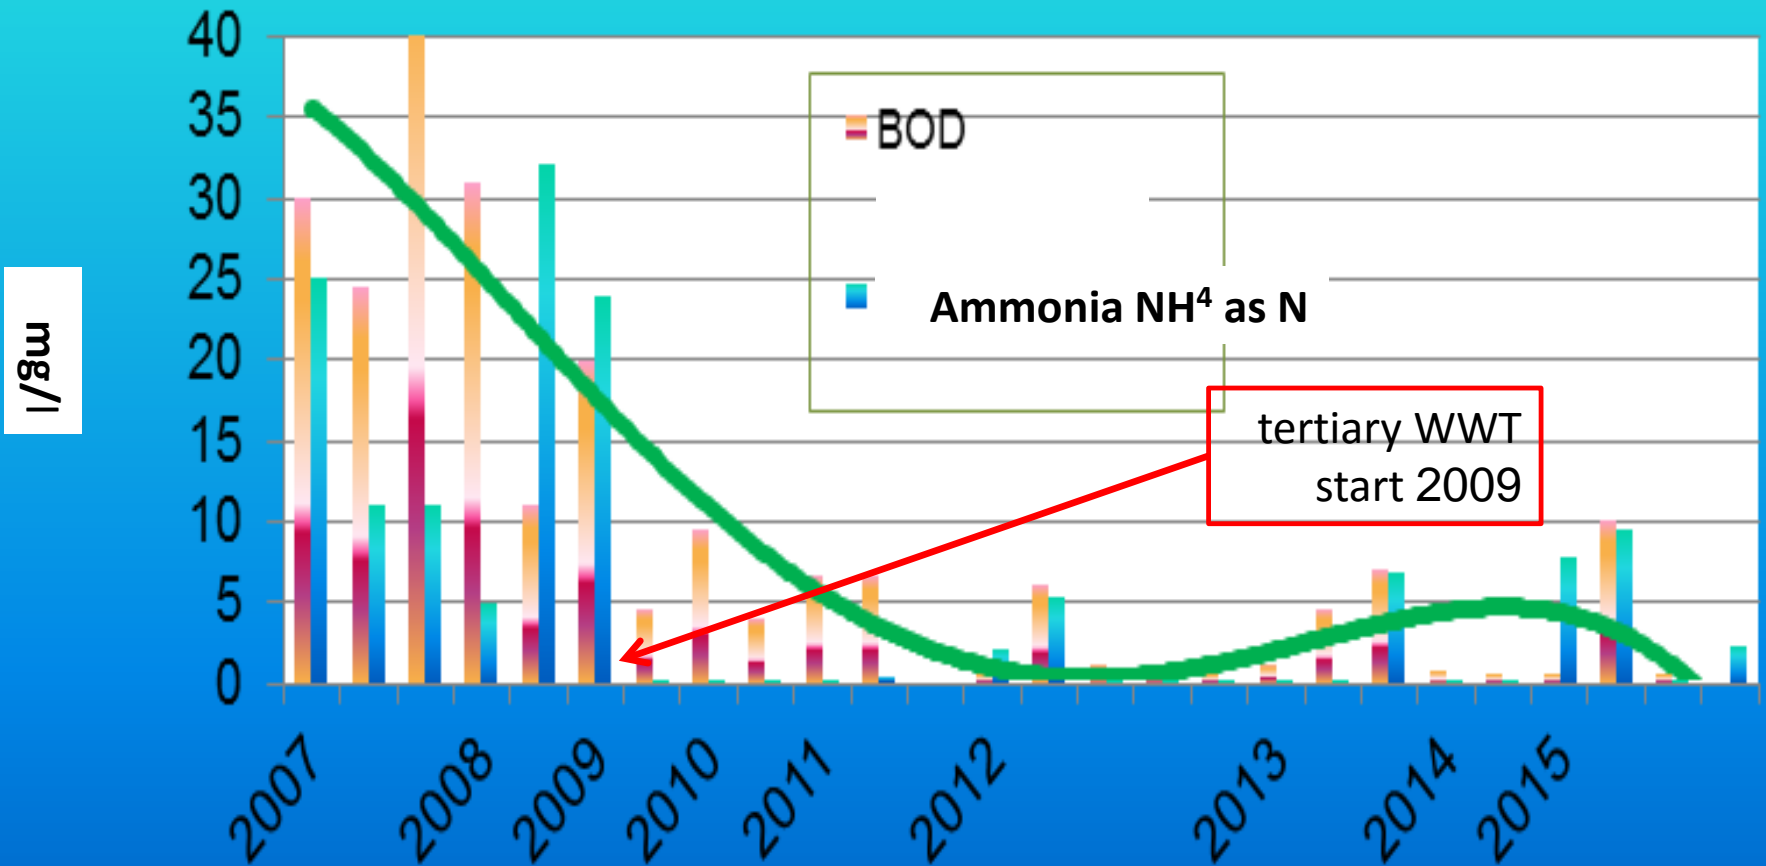
BOD & ammonia reduction in the mid reach of the yarqon river

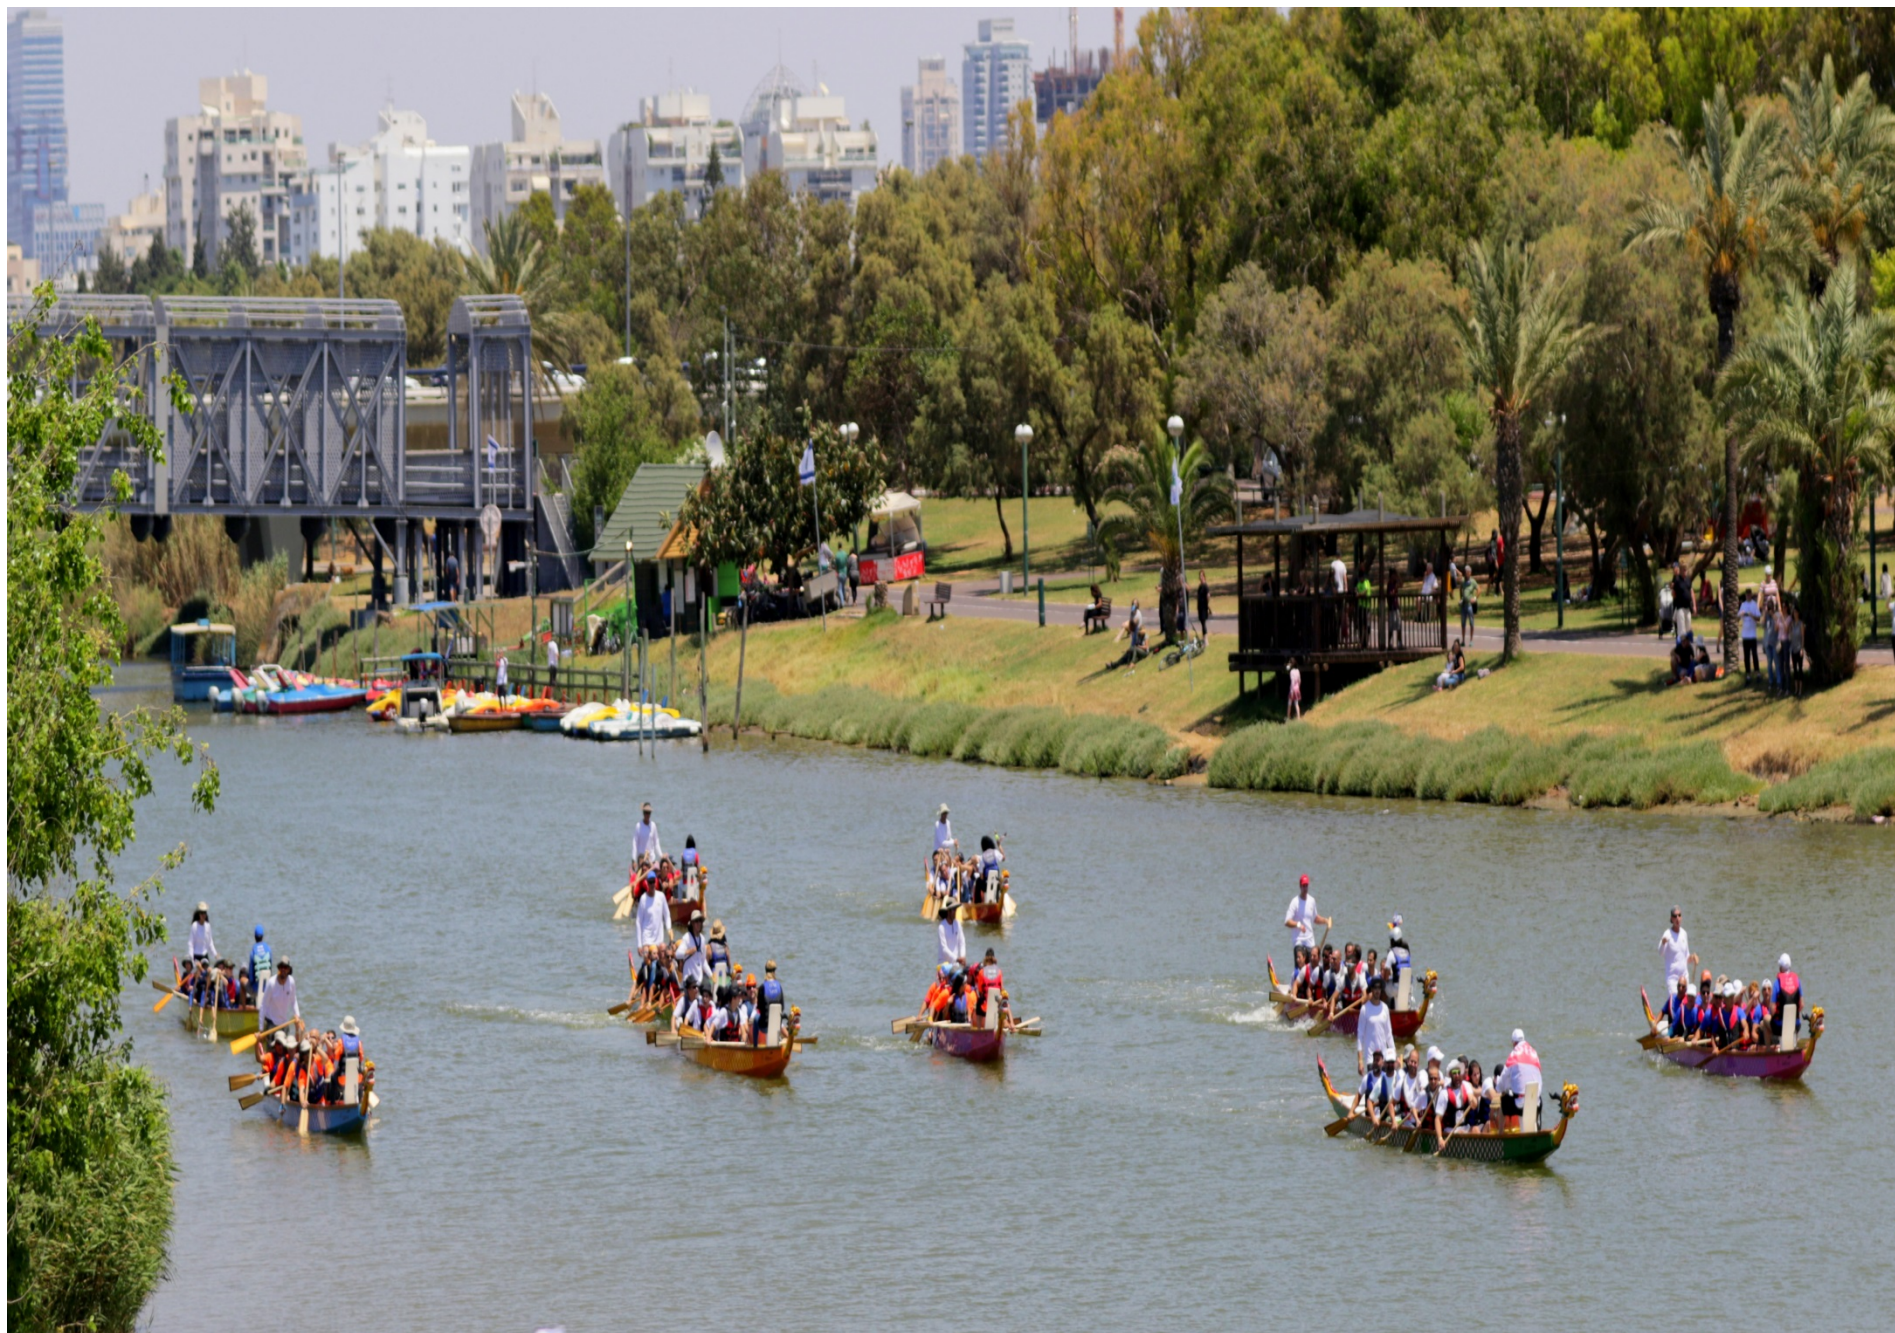
**Constructed
wetland**

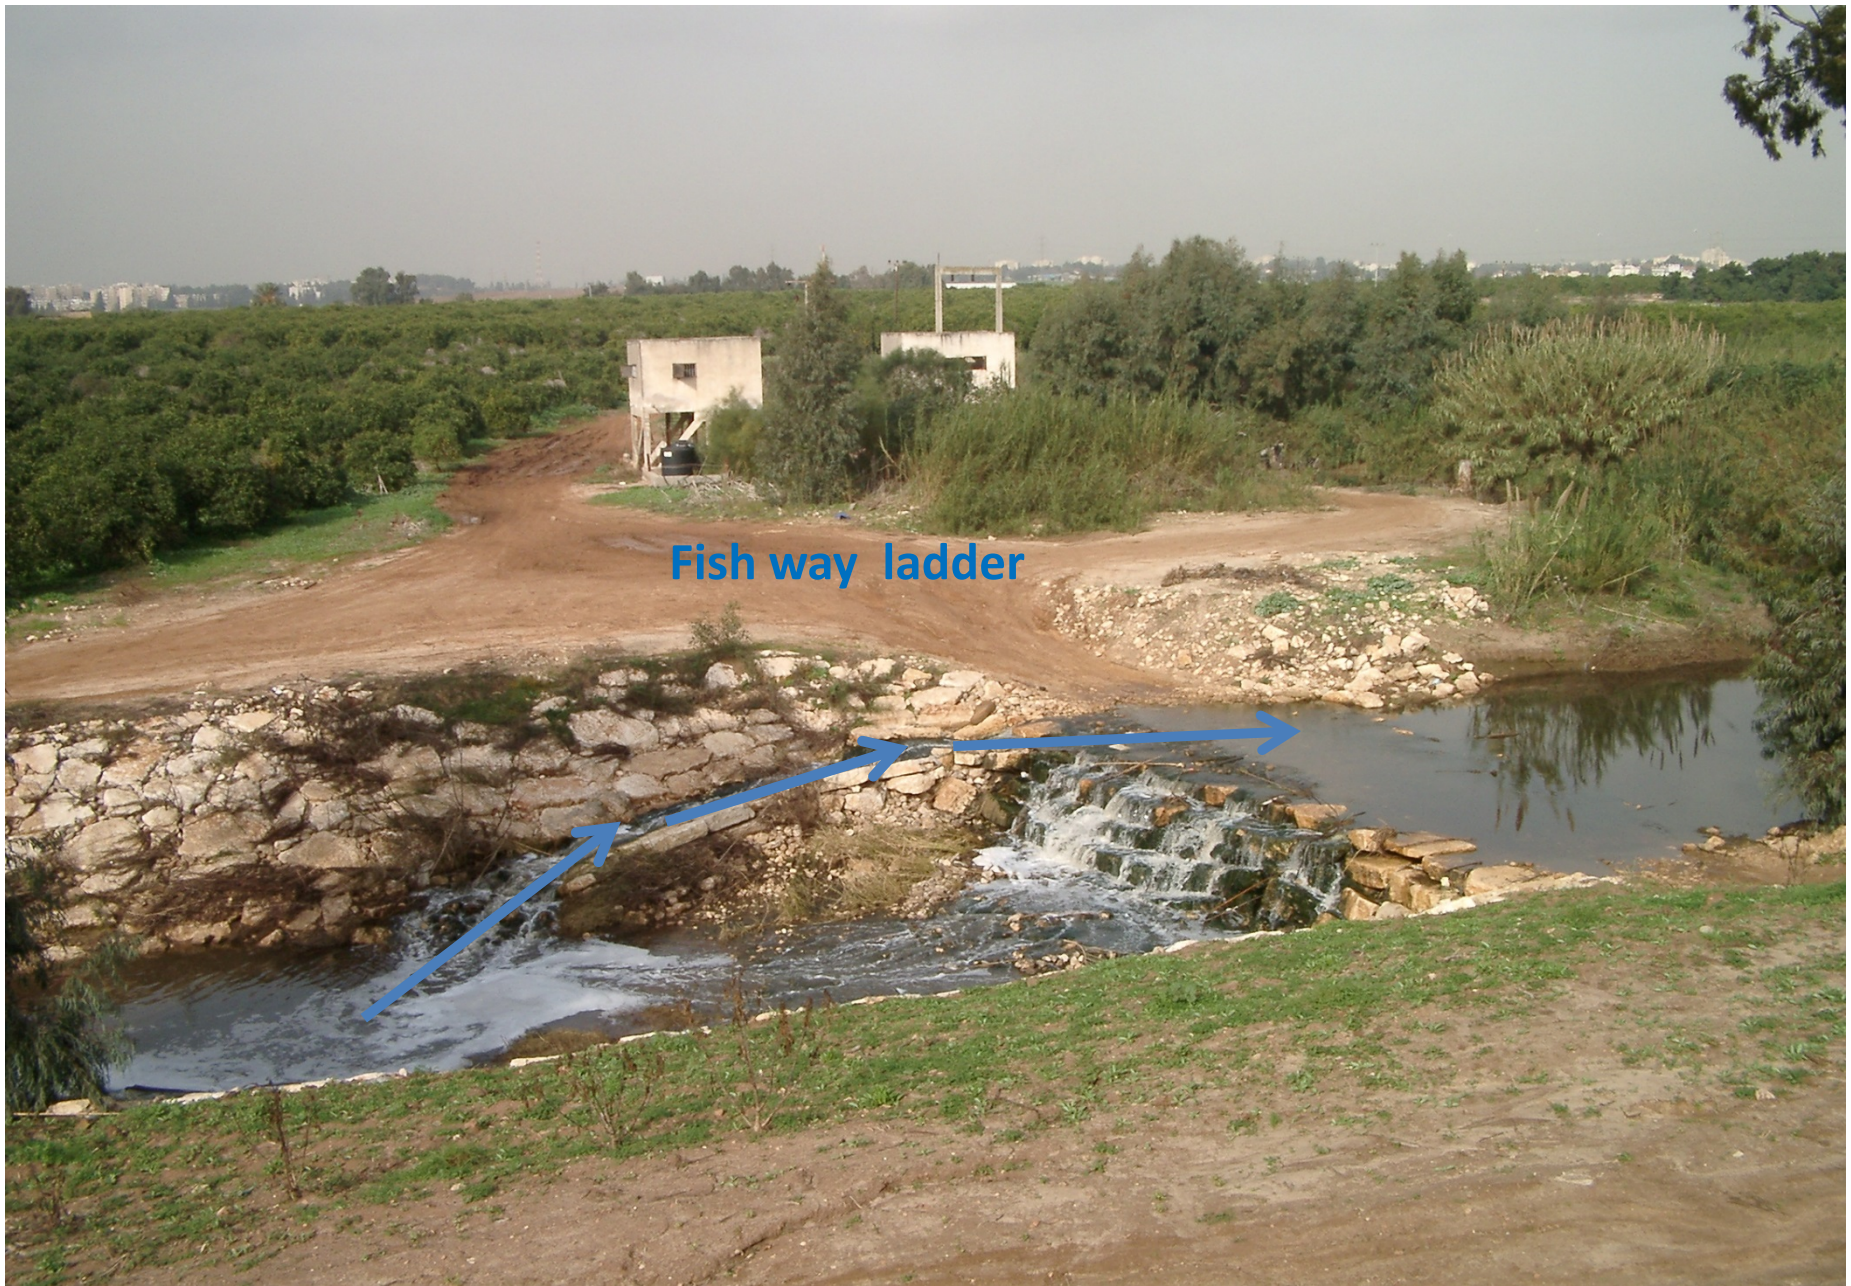
Fish way ladder

Migrating up steam

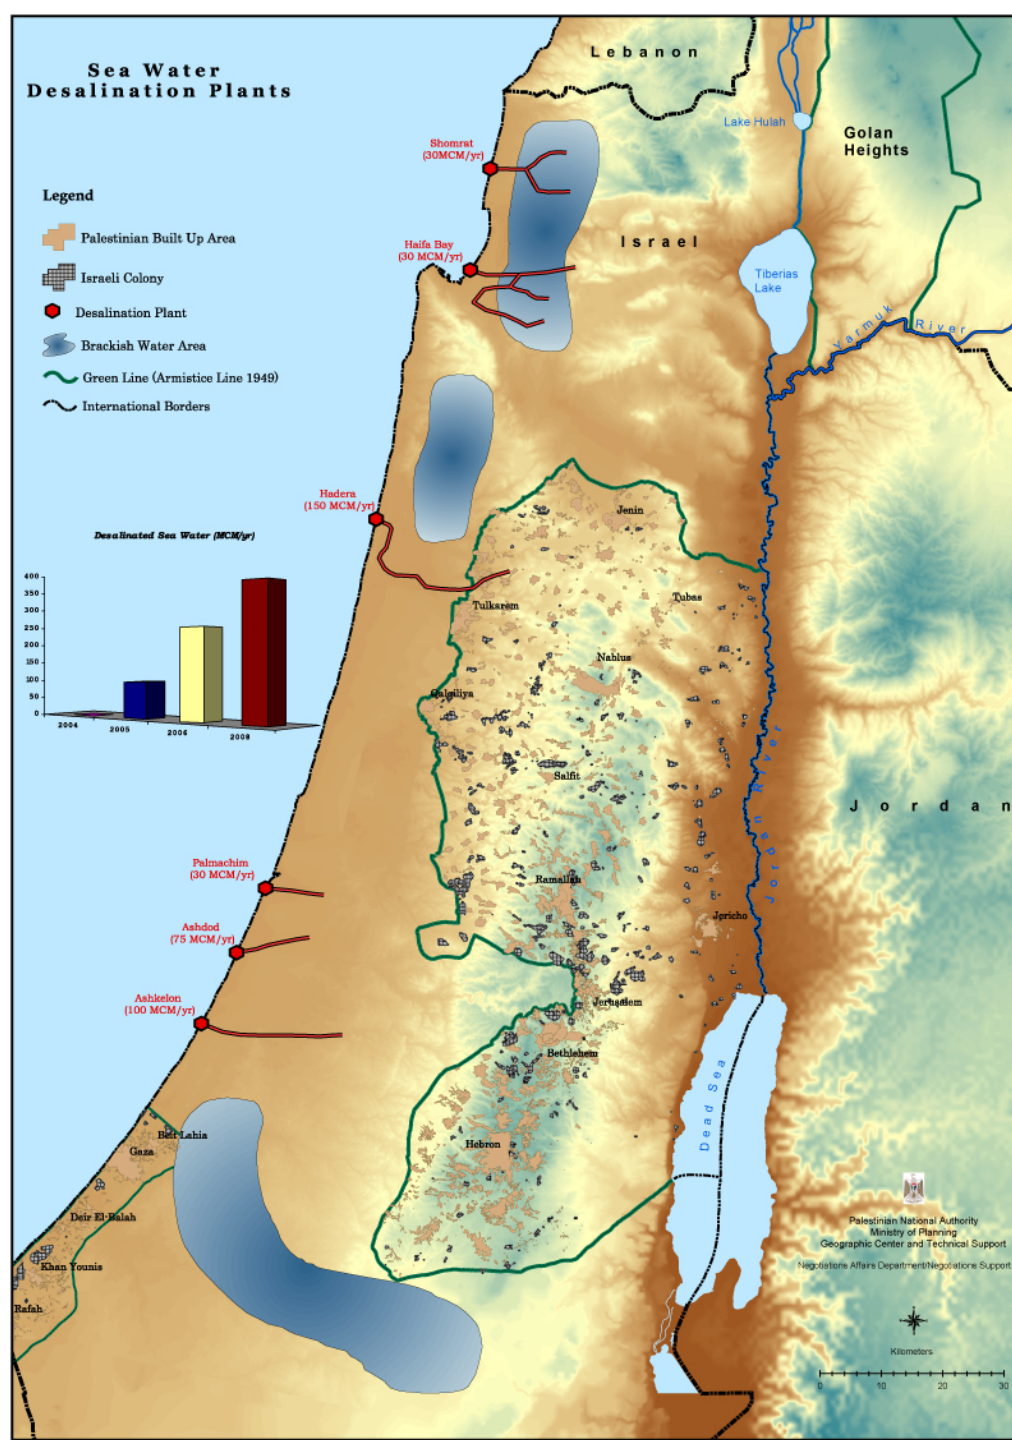
Sea Water Desalination Plants

Desalinated Sea Water (MCM/yr)

By 2016 Desalination supply 100% of domestic water consumption

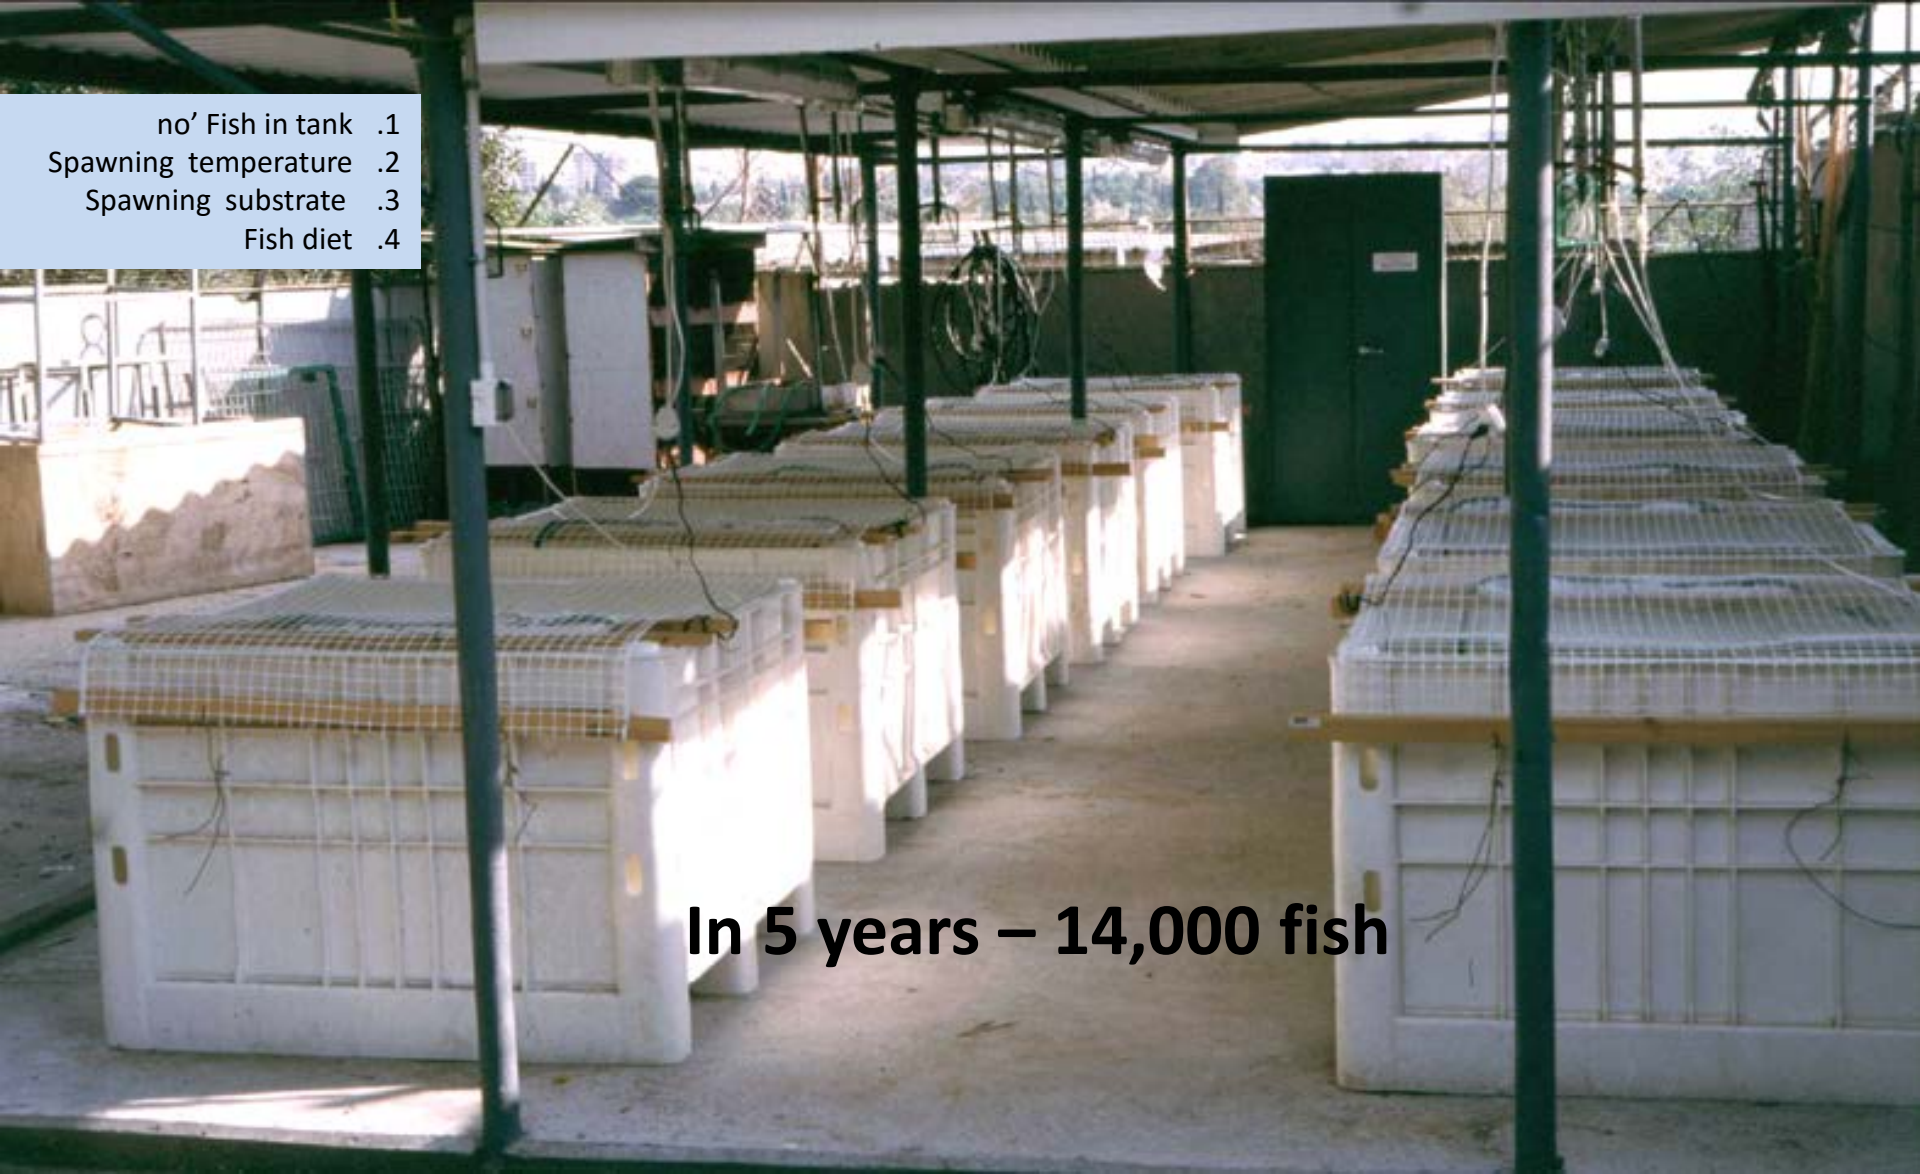
The facility for maintaining - breeding the fish (Ichthyological Laboratory at Tel Aviv University)

- no' Fish in tank .1
- Spawning temperature .2
- Spawning substrate .3
- Fish diet .4

In 5 years – 14,000 fish

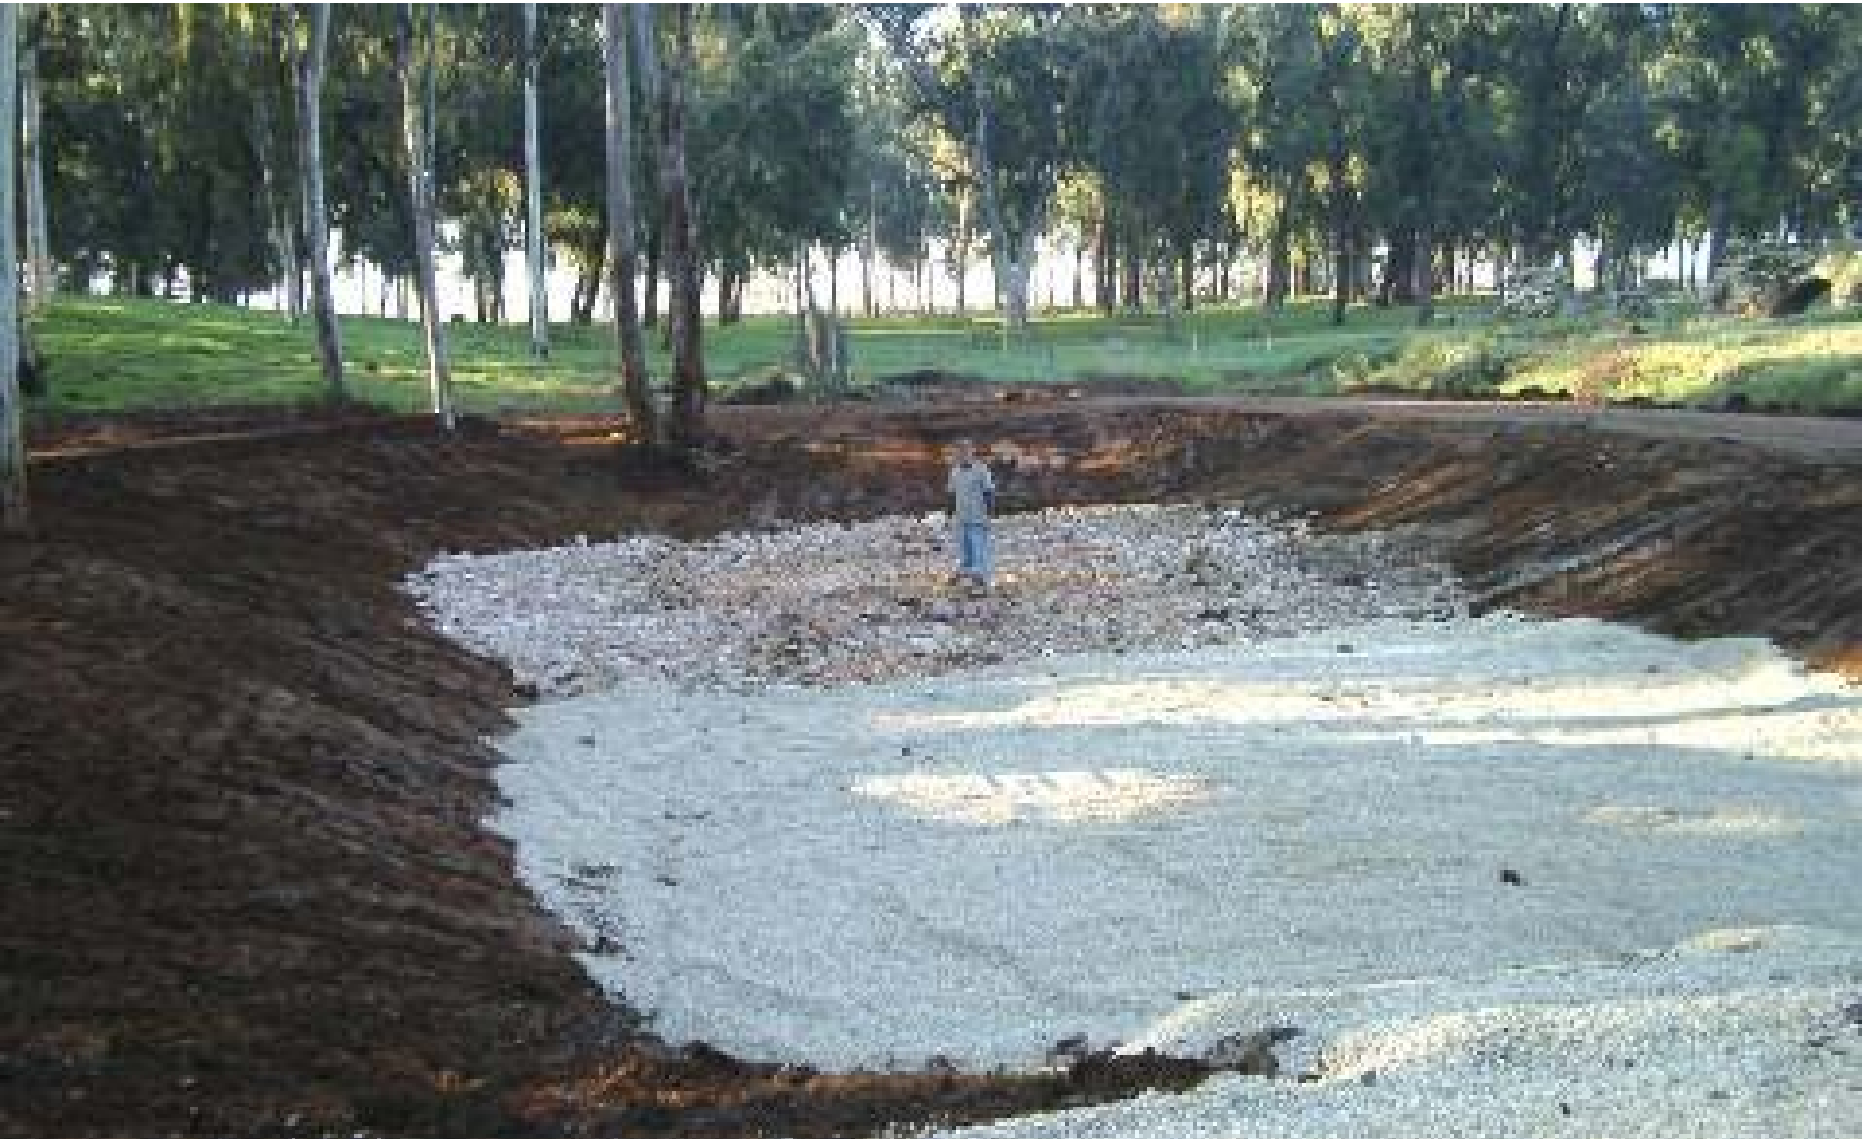
The engineered bottom of the experimental side pond near Yarqon River

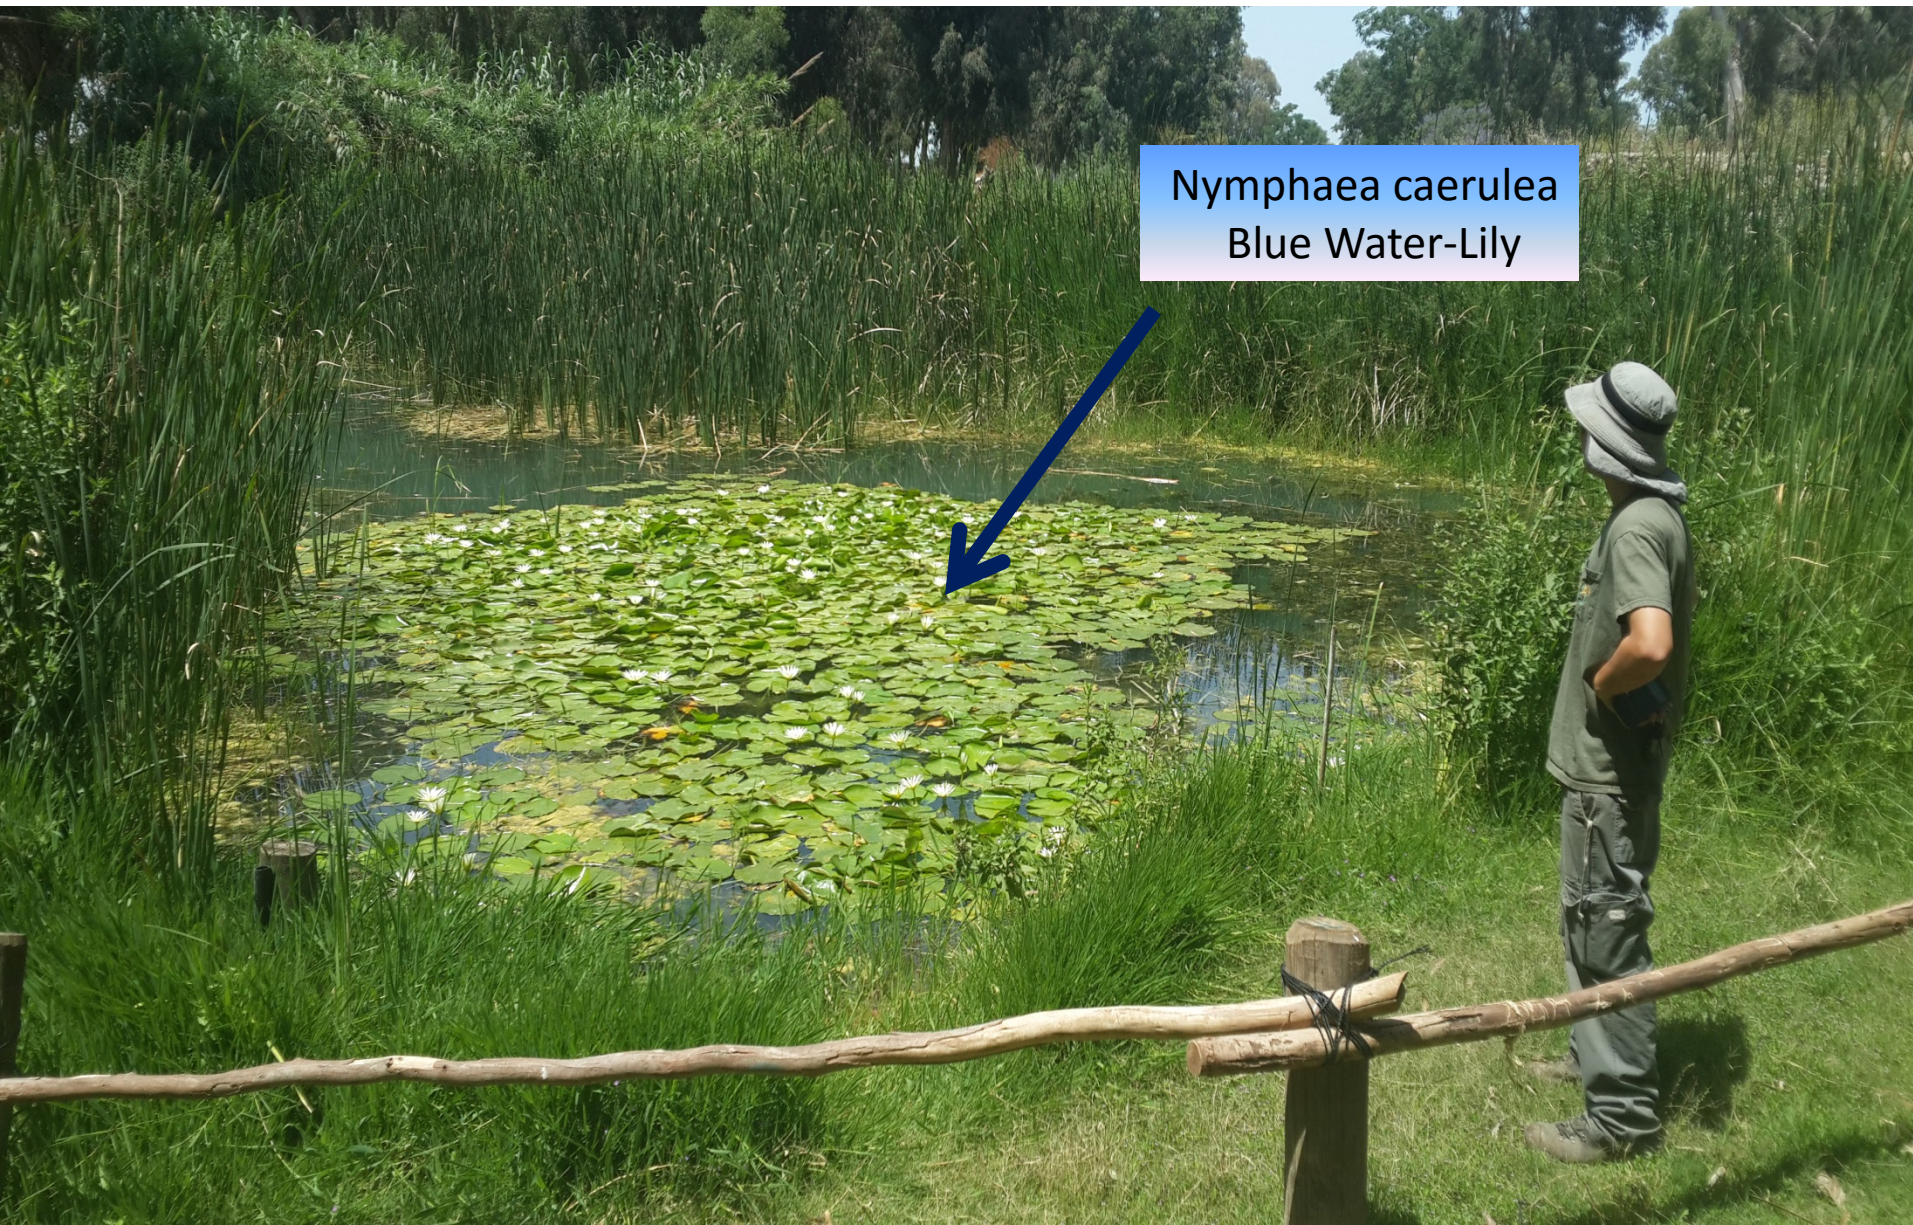
engineered Spawning pond

Screen net

engineered spawning pond
